17. DISTRIBUTION STATEMENT (of the abstract entered in Block 20, if different from Report) 6 National Dam Safety Program, Stump Pond Dam (Inventory Number 746), Susquehanna River Basin, Cortland County, New York. Phase I Inspection Report.

PHASE I INSPECTION REPORT
NATIONAL DAM SAFETY PROGRAM
STUMP POND DAM
I.D. No. NY 746
CORTLAND COUNTY, NEW YORK

Name of Dam:	Stump Pond Dam I.D. No. NY 746
State Located:	New York
County Located:	Cortland
Watershed:	Susquehanna River Basin
Date of Inspection:	October 23, 1980

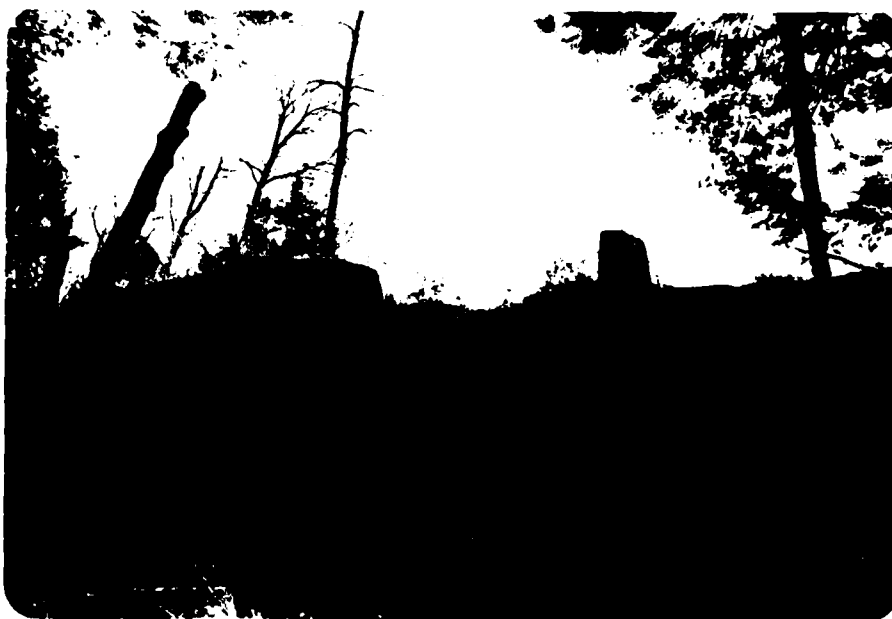
5. A bulge was noted in the laid up stone segment below the spillway section (see photo 7).
6. The stones at the right end of the dam were displaced upward above the horizontal with respect to the remainder of the dam (see photo 8).

Photo 8 - Downstream Face of Dam -- Note Tilting Stones to Left and Concrete Footing at Base of Dam
